AMERICAN EMERGENCY VEHICLES

General Motors has issued an Upfitter Integration Bulletin dated July 16,2014 (see attachment). The subject of the bulletin is titled Improper Engine Block Heater (Option K05) Continuous Power. GM states that the engine block heaters should not be tied into any circuit that could activate the engine block heater unless the outside temperature is between -18 degrees and -29 degrees C and should not to be continuously plugged into an "A/C" source.

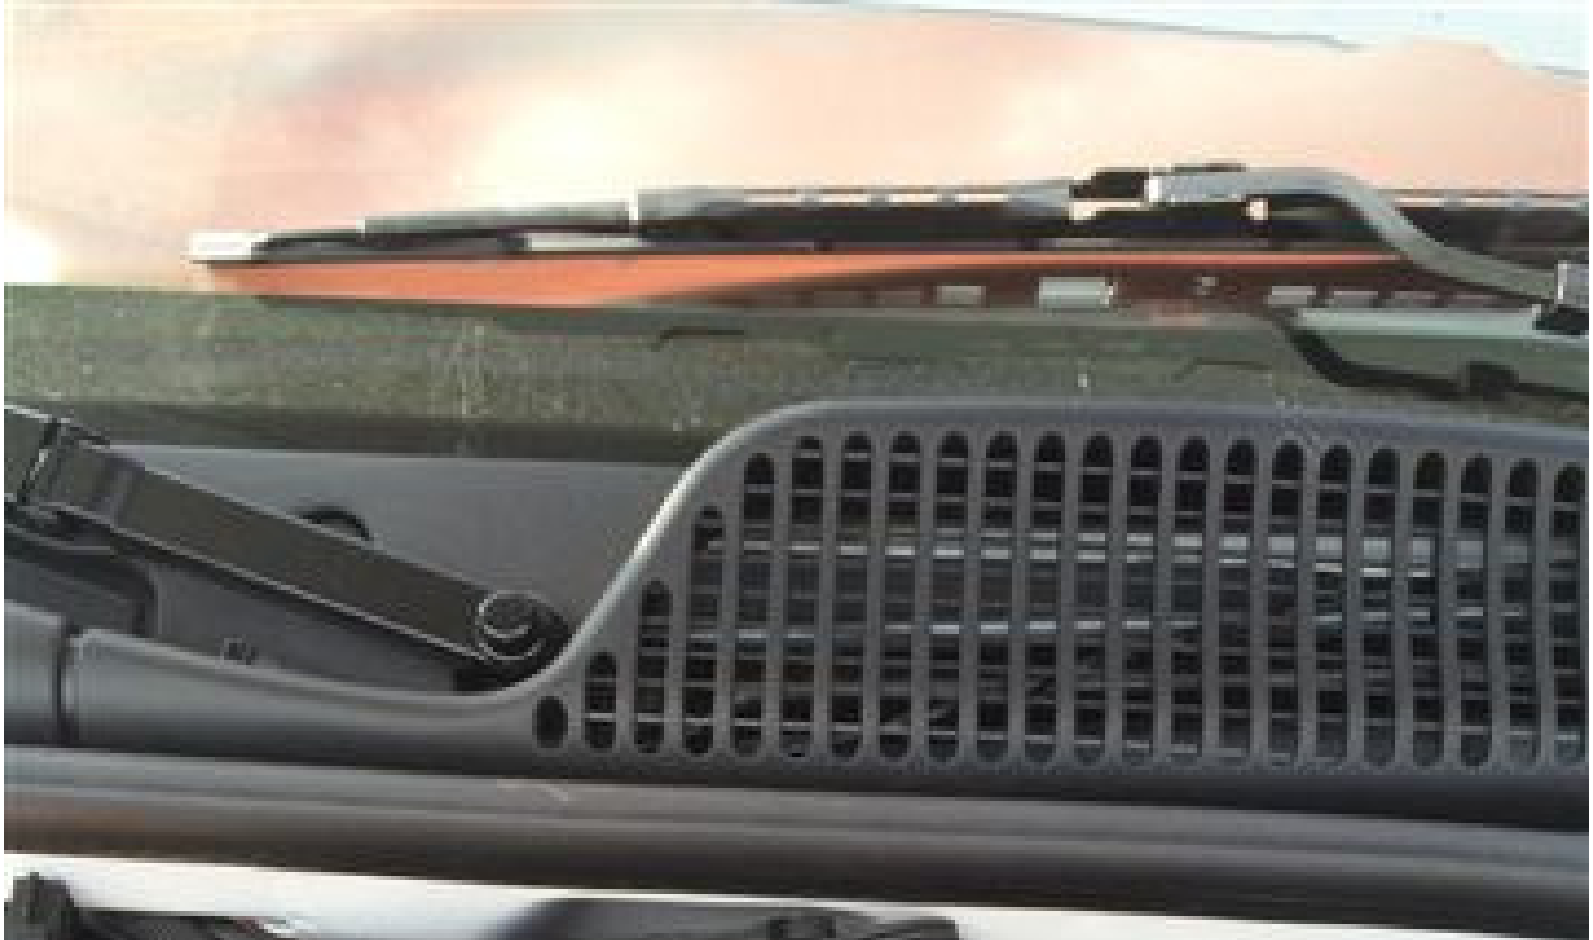
Step 1) Raise the hood and locate the 115 volt male and female electrical plugs
Reference Photo #1

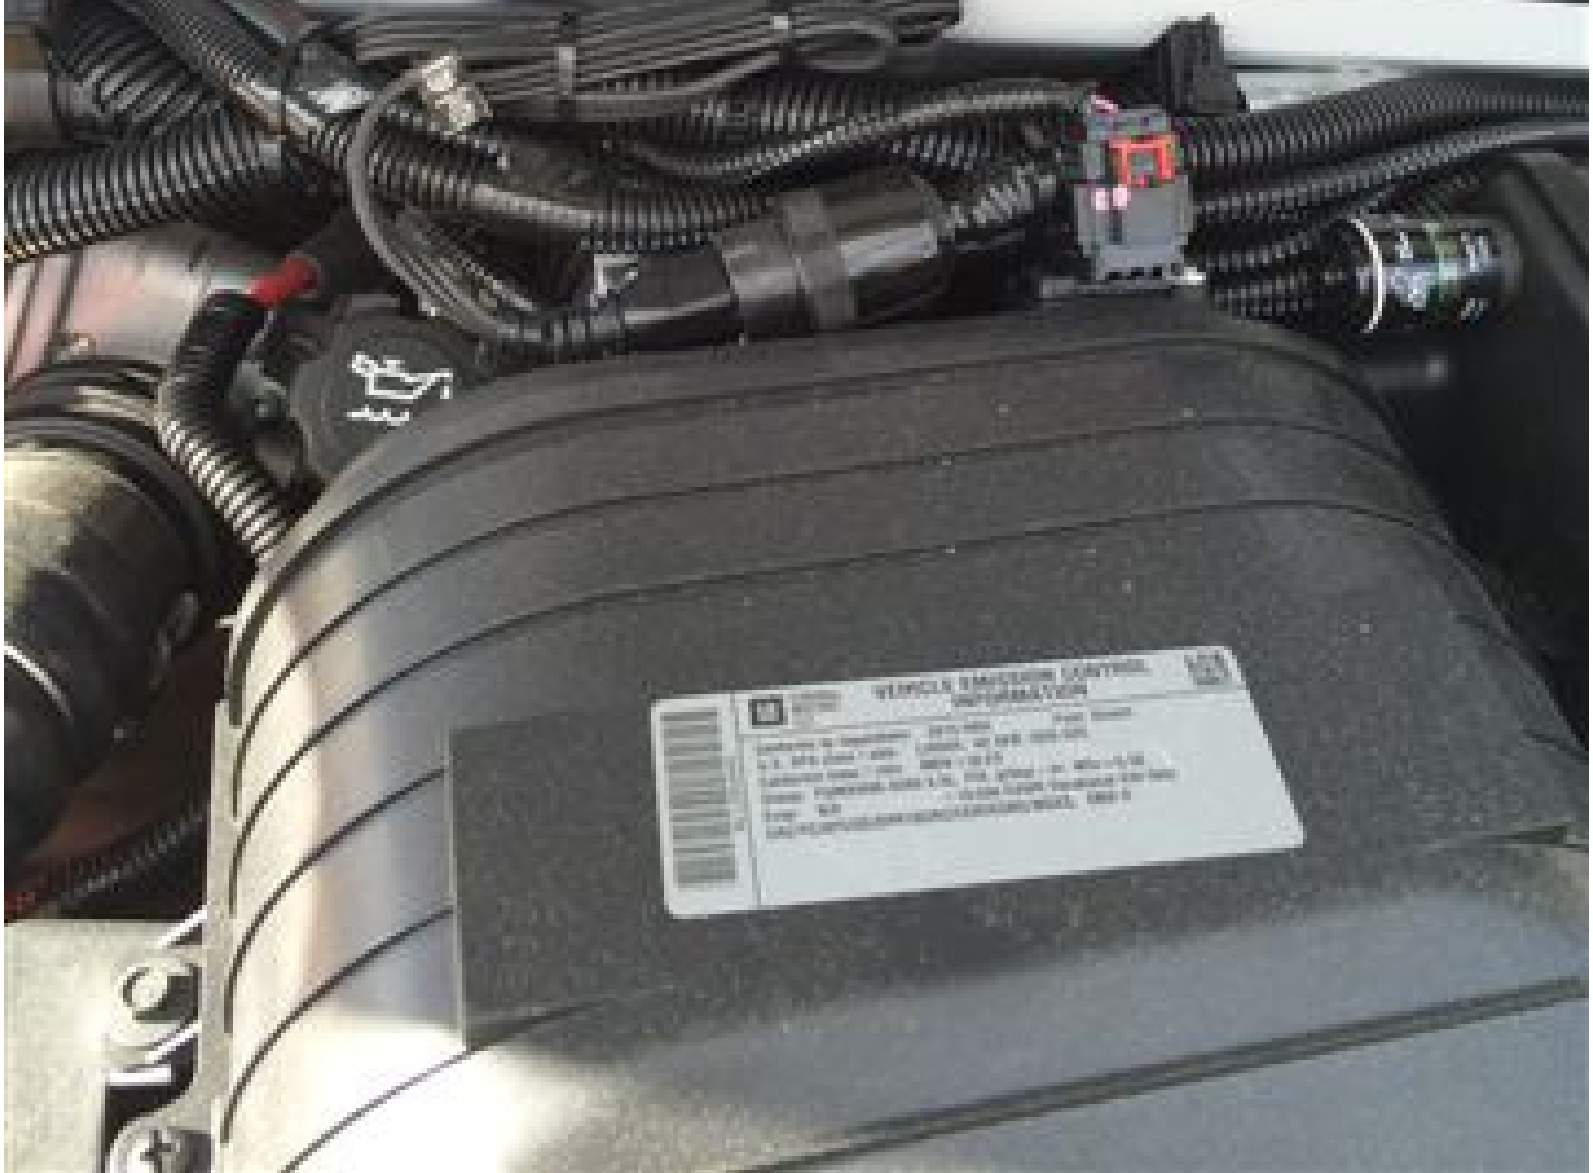
Step 2) Disconnect / unplug the male and female connectors. Reference Photo #2

Step 3) Recommend placing an outlet plug protector into the female receptacle
